Keeping a Promise to the Past

Copper Alloys

Case Studies in Copper Alloy Conservation

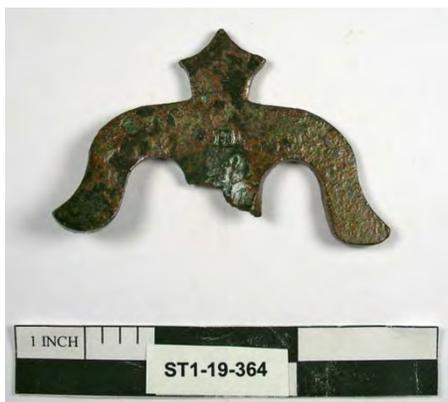
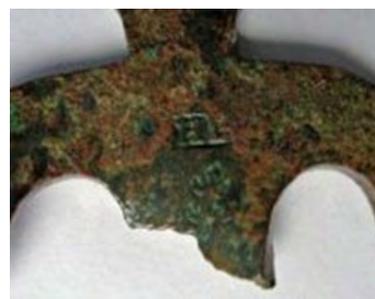
Decorated Copper Object

This handle was sent to the conservation laboratory for routine cleaning. The surfaces were fairly clean and were covered in a well adhered obscuring corrosion.

As with many coppers, the corrosion was colored green, brown, red and black. The object was not complete and had suffered some damage during burial. Some of the corrosion was very dense in the middle area. The object was mechanically cleaned and the corrosion was carefully removed under the microscope. During cleaning, a design appeared in the surface of the copper alloy. As more corrosion was removed, it became apparent that a maker's mark of some sort was impressed into the surface of the object. This mark revealed initials of "HL" in the surface as well as an emblem or symbol below. Because the object was damaged on the bottom half it is not clear whether the complete mark is revealed. As with so many objects, even though a mark like this is uncovered, it is still very difficult to identify what the mark means. But one thing is for sure, the mark is another clue to our past and is now available for further research and study.

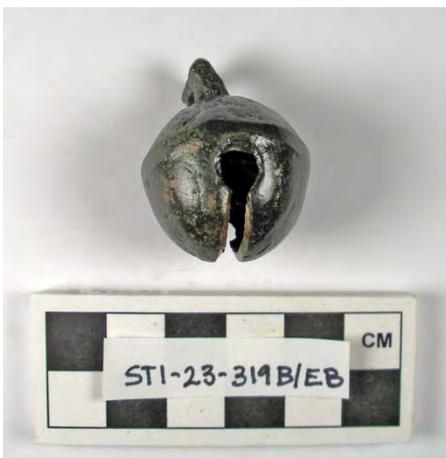
Copper Alloy Bell

When this small copper alloy bell was brought into the conservation laboratory for cleaning it did not seem any different than any of the other copper alloys from HSMC. Most of the copper alloy artifacts at HSMC are in good condition with core metal remaining. The cleaning process is straightforward, and involves mechanical cleaning of the surfaces under the microscope. Upon investigative cleaning of the bell however, we discovered something inside the bell. A small round iron clapper was still present inside the bell. The routine cleaning of this bell would suddenly take on a different direction.

When objects are composed of two or more materials they are referred to as “composites” in conservation. This is because the treatment of such objects will be different than that of an object which is only composed of one material. The bell would now be a more difficult treatment because the copper alloy and iron components would be cleaned differently. And the cleaning technique for one of the materials could potentially damage the other material. Conservation treatment of composite artifacts are more complicated and are always left to a professional conservator for this reason. Sometimes one of the materials is in much better shape than the other, and one of the materials may be sacrificed to the other to ensure the long-term stability of the entire object. This type of decision is not made without careful consideration, and the conservator will always lean toward the more sensitive and unstable material first for treatment.

Both the copper alloy and iron parts of the bell were in fairly good condition. This is very unusual as well. When dissimilar metals are in contact, a corrosion cell naturally occurs. The metal which is lower on the galvanic series (or the least noble metal) will corrode preferentially to the other metal. When copper and iron are in close contact and form this type of corrosion cell, the copper is always preserved much better than the iron. However, the iron in the bell remained in tact and contained a significant amount of core metal making it an excellent candidate for treatment.

The copper alloy part of the bell was cleaned in the usual manner. When the cleaning was completed it was time to clean the interior iron clapper which was heavily corroded and adhered to the inside of the bell. It was very difficult to get a tool inside the bell to clean the iron sufficiently. In the end it was decided to use a very small stream of air under low pressure to loosen the corrosion and release the clapper. Excess corrosion and dirt were removed from the interior of the bell using small blasts of air in localized spots. After cleaning, the bell was rinsed and degreased and left to dry. Upon moving the bell to complete treatment it was noticed that the clapper had loosened inside and “sound” was restored to the bell. While the intent of any conservation treatment is not to “restore” the object to its original form, especially artifacts whose historical integrity is tied to change during burial — this was as much a surprise to the conservator as it was to the curator. And one can’t help but wonder if the sound of the bell is close to its original or not.

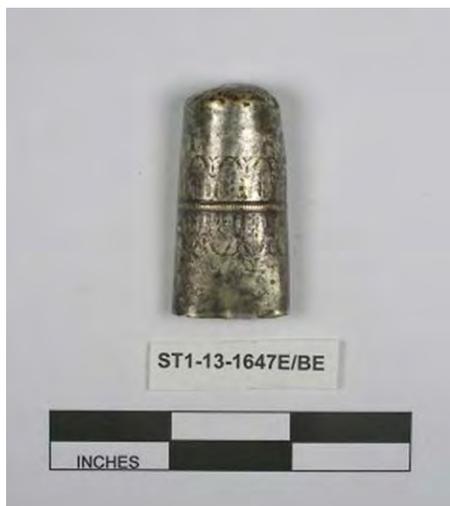
Copper Alloy Pin Case

A visual examination of this object prior to treatment indicated the surface was covered in debris, especially the interior, which was filled with small stones and roots. Stable black-colored corrosion products were evident, but unstable light green spots of corrosion were also visible. Light green corrosion could be an indication of bronze disease, which is an active form of corrosion and must be removed to stabilize the object and ensure no further deterioration of the original material occurs. No analytical study was performed to confirm the corrosion was in fact bronze disease. In the X-ray, deep pitting was visible and these areas corresponded with the areas of green corrosion, indicating it's an active corrosion. To our surprise, the X-ray also revealed evidence of a surface decoration that was being completely obscured by debris.

Due to the light green spots of active corrosion, this artifact was deemed in unstable condition and in need of immediate treatment. The treatment goal was to stabilize the object by removing all active corrosion and debris

Surface dirt was removed using a small dry brush. The mass of small stones and roots on the interior space were removed using a scalpel. After the soil removal, the stable black corrosion layers on the exterior surface were removed using a fiberglass brush and steel wool swabs. To reach the interior corrosion, a steel wool swab was used. Under magnification, active light green corrosion spots were carefully removed using a micro scalpel. The object was then rinsed with acetone to remove cleaning debris and any remaining soil. The object was then coated with an acrylic resin, Acryloid B-72, to provide a moisture barrier and to protect from oils on hands when handling.

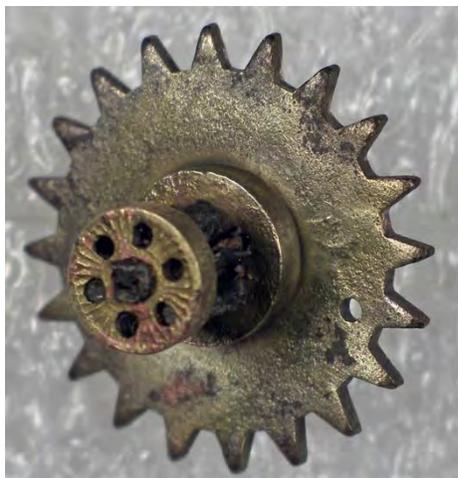
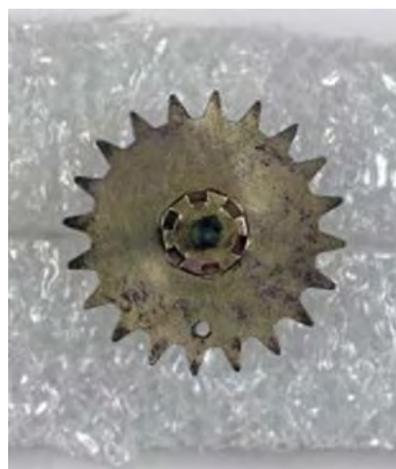
Clock Escapement

The surface of this 19th- or 20th- century object had a large mass of deposits and orange corrosion products, which is evidence of corroded iron. When touched to a magnet, parts of this object had a strong pull indicating the presence of ferrous iron. But unlike iron, an X-ray showed high levels of core metal remained and that the object had a clear outline indicating no corrosion had been present, which is common with copper alloys. The object's "teeth" were in very stable condition and showed no signs of active corrosion and had no magnetic pull, indicating they were copper alloy. Therefore, based on our examination, this object is a "composite" artifact consisting of both copper alloy and iron components. The X-ray, however, could not confirm nor disprove the object's true identity. Due to the object's shape, it was temporarily categorized in the condition report as a spur rowel.

Since the cleaning technique for one of the materials could potentially damage the other material, careful consideration had to be made. For example, distilled water could not be used to clean the sections of iron and the copper could not be air abraded. Instead, air abrasion techniques with aluminum oxide powder were used to decrease both soil and corrosion products to the iron sections only. The iron was then treated with tannic acid, which is only a corrosion inhibitor for ferrous metal. Except for the use of distilled water, traditional copper cleaning techniques were used on the copper alloy sections, which included the removal of corrosion products with a fiberglass brush. Once all corrosion products were removed, the entire object was coated with Acryloid B-72.

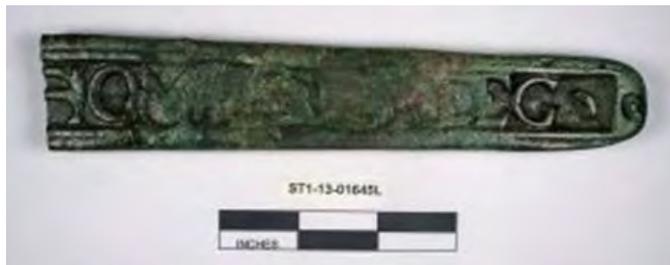
Copper Alloy Handle

Prior to treatment, this copper alloy handle was examined visually by a conservator to determine its condition. It was noted that lettering was visible, but partially obscured by a thin layer of dark green corrosion from burial. Presence of dark green colored corrosion is evidence that the corrosion

products are stable and not an active threat to the object's materials and condition. Next, an X-radiograph of the object was studied. X-rays can provide essential information about the condition of an object and if the object is stable enough to proceed with conservation treatment. From these X-rays, various condition and corrosion levels can be seen. Fragile objects have faint or dark-colored spots indicating their weakened state. Light or white colored X-rays indicate the presence of a denser metal core on stable objects. We can also see any decorative details that are obscured or masked by corrosion products and soil accretions. The X-ray of this handle indicated that it has retained its solid metal core and there is no evidence of structural damage, so this object can withstand the treatment process. The X-ray also revealed that one end of the object was broken.

The cleaning of this object revealed evidence of significant wear to the middle of the handle indicating the skillet this handle was originally attached to was often used. This object may have been used while the Calvert family occupied the house or when the house was being used as an inn. Although the words on the handle could not be deciphered, they would indicate the objects maker.

The goal for every treatment is to stabilize the object so that further deterioration of the original materials is terminated. All treatment materials applied to the object to further stabilize it must also be reversible. In this case in particular, revealing the lettering was important as well. Treatment started by soaking the object in a bath of distilled water to remove excess soil. A small soft brush was used to remove the soil and the corrosion layer was reduced mechanically using a fiberglass brush and scalpel under magnification. A quick rinse with acetone was used to remove any cleaning debris and to de-water the object. Once dry, two coats of Acryloid B-72 in acetone was applied to the entire object. The B-72 provides a moisture barrier and allows the object to be handled safely. The handle, like all objects treated, was repackaged in a clean and pierced, archival stable polyethylene bag.

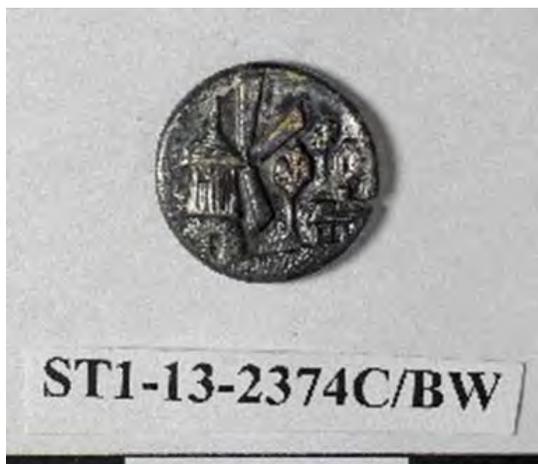
Button Decorated with Windmill

This highly decorative, machine stamped copper alloy and iron button has landscape imagery that was popular during the 19th century – a windmill. Upon initial visual inspection, the face of the button was covered in corrosion products common for copper alloys and had no magnetic pull. The back was made from iron. Very little iron remained, but red corrosion products and a weak magnetic pull confirmed its existence. Since the cleaning technique for one of the materials could potentially damage the other material, careful consideration had to be made.

In this case, the copper alloy section was very stable, but the iron section had almost completely deteriorated. Due to its deterioration, the iron corrosion had to be removed by mechanical means under magnification with a micro scalpel. The corrosion layers on the copper alloy side were removed with a micro scalpel, fiberglass brush, and steel wool swabs. After the corrosion was removed, the button appeared to be plated with a gold-colored metal, but no analytical study was performed to confirm the identity of this third metal. After being rinsed with acetone, the button received two coats of Acryloid B-72, which acts as a moisture barrier and will allow this object to be handled without the risk of damage caused by skin oils.
